RADIO

Démarrer le programme et choisir le bouton « Sélectionner »

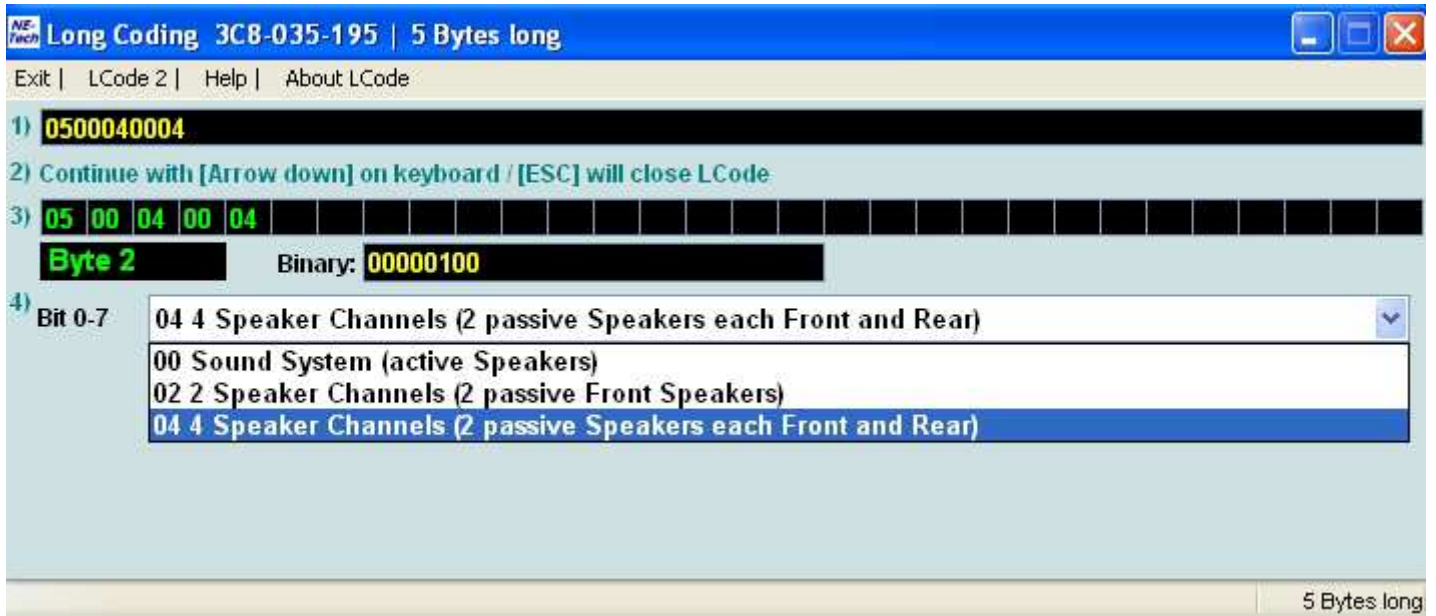
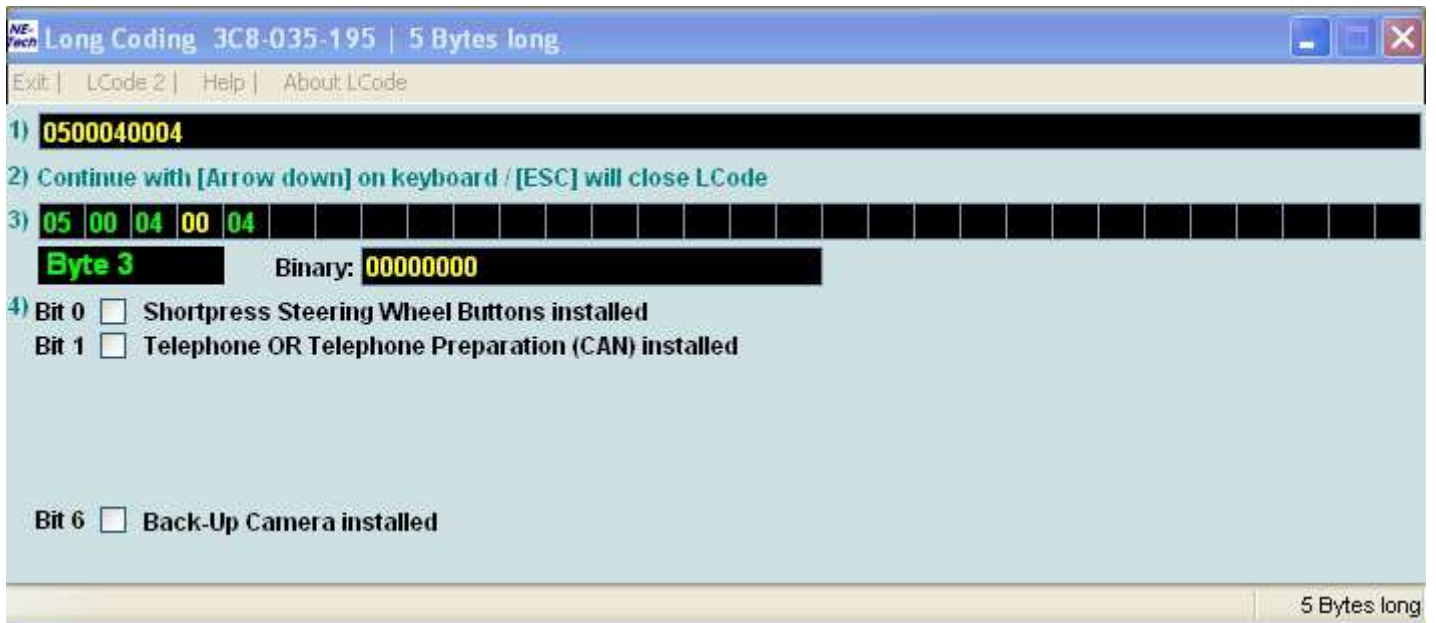
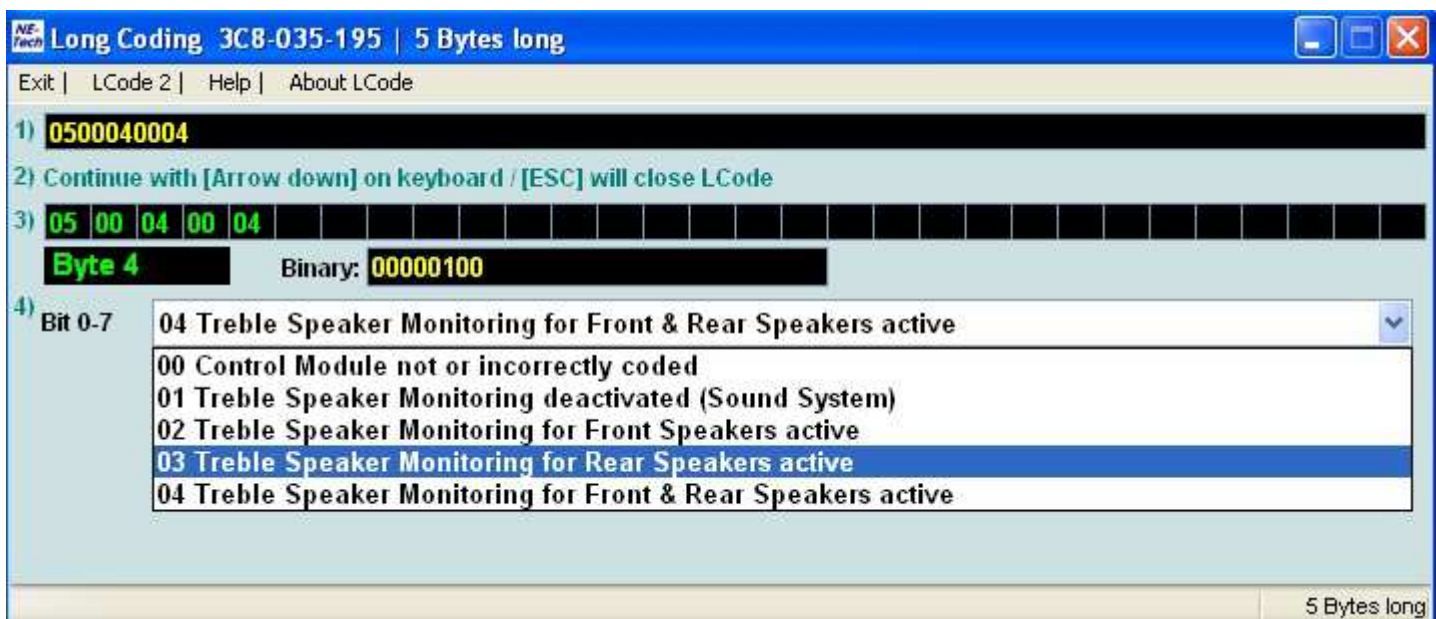
Codage - 07

NE Tech Long Coding 3C8-035-195 | 5 Bytes long

1) **0500040004**

3) **05 00 04 00 04**

Byte 0 Binary: **00000101**

4) Bit 0 **AUX-IN Access restricted**
Bit 1 CD-Changer/iPod/USB Connection Monitoring active
Bit 2 **AUX-IN Connection Monitoring active**
Bit 3 Parking Aid installed

After first inserted value, this is the changed Coding value. Coding value is copied at closing VCDS 5 Bytes long

1) **0502040004**

3) **05 02 04 00 04**

Byte 1 Binary: **00000010**

- 02 Skoda Soundsystem
- 00 Sound System not installed
- 01 Volkswagen Sound System OR Dynaudio Sound System
- 02 Skoda Soundsystem**
- 05 Dynaudio Sound System (Coding may be incorrect / see TPI 2019755)

The changed Coding is automatic copied to VCDS, with [Exit] / [ESC] 5 Bytes long
